The Road Inventory of Tualatin River National Wildlife Refuge Sherwood, OR

Prepared By:
Federal Highway Administration
Central Federal Lands Highway Division
February 2013

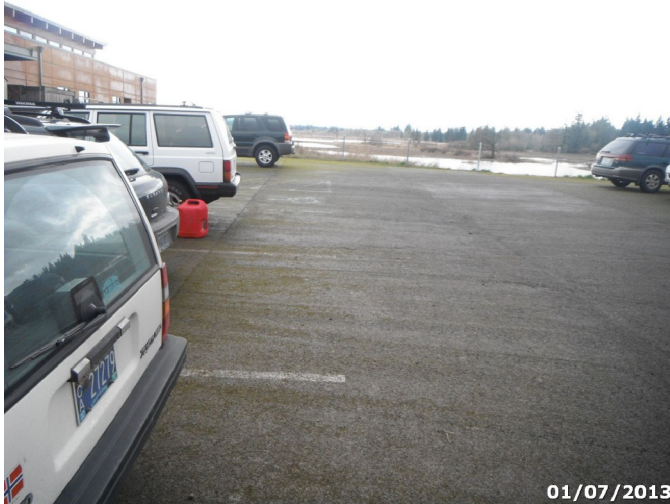
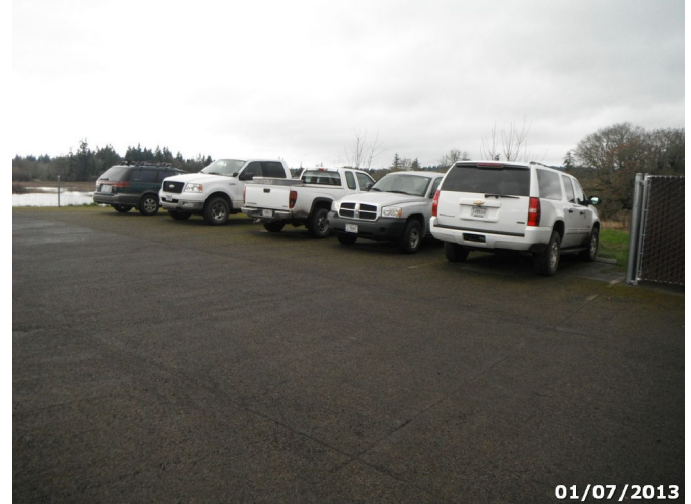
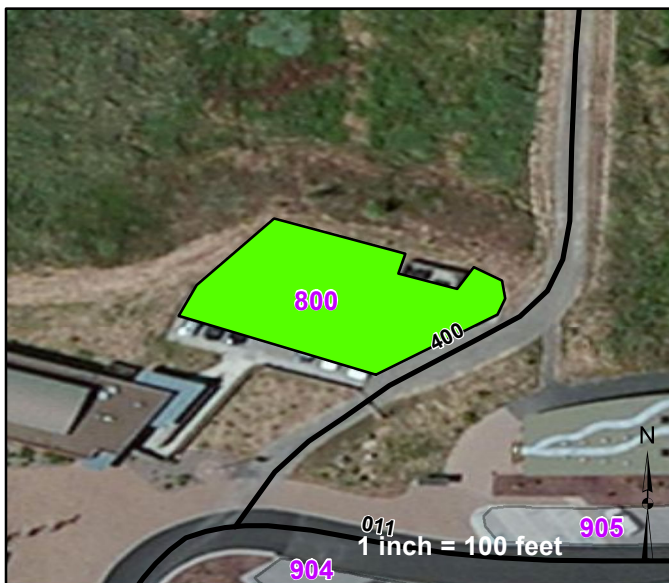
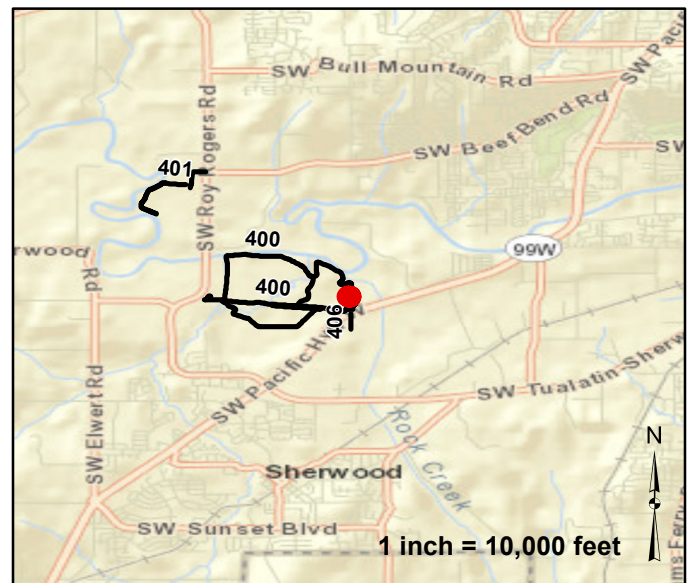
Route Number: 800
Administrative Building Staff Parking
 From Steinborn Operations Road (Route 400)

Asset Number	Area (Sq Ft)	Spaces	Condition	Surface Type	Cost to Improve	Inspection Date	Current Replacement Value
10055097	5453	12	Good	Asphalt	\$1,200	01-07-2013	\$56,600

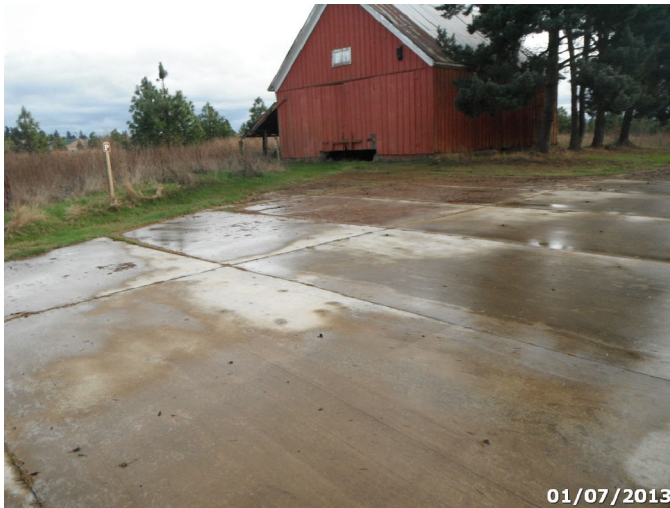
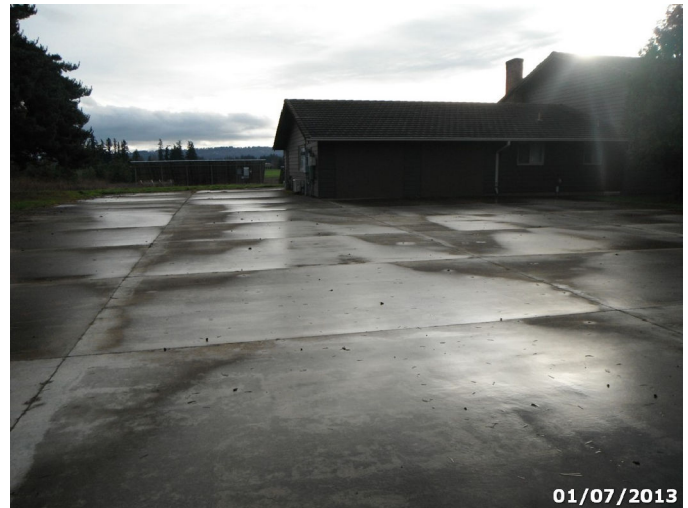
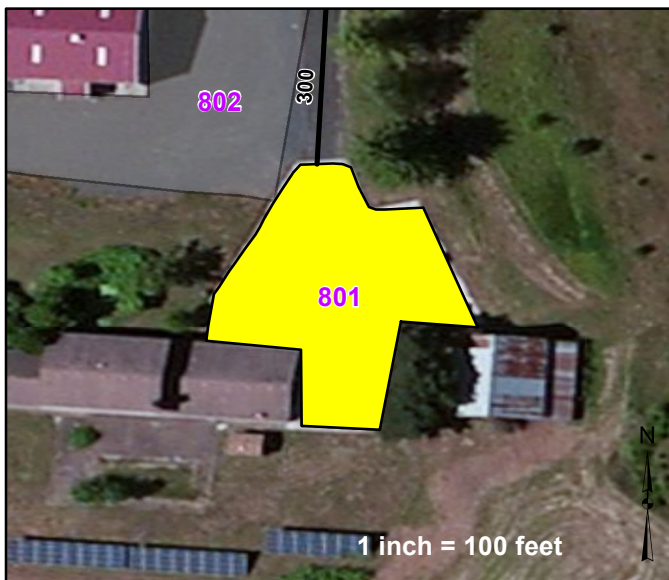
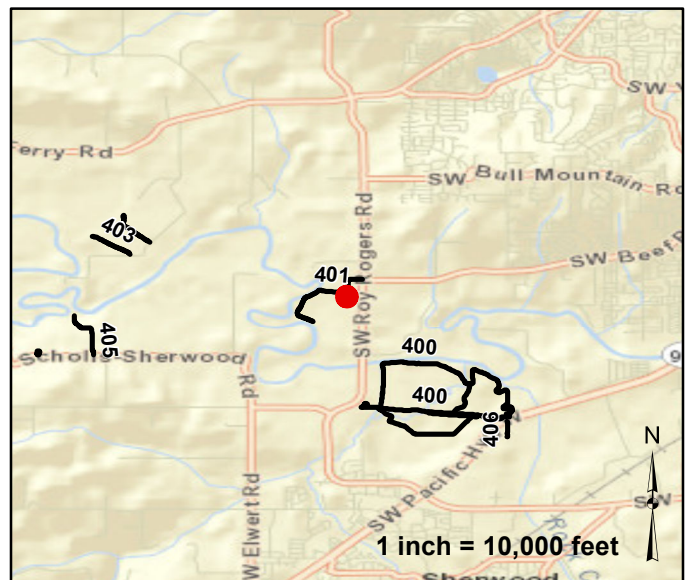
Route Number: 801

Asset Number	Area (Sq Ft)	Spaces	Condition	Surface Type	Cost to Improve	Inspection Date	Current Replacement Value
10004598	7513	20	Fair	Concrete	\$15,600	01-07-2013	\$94,700

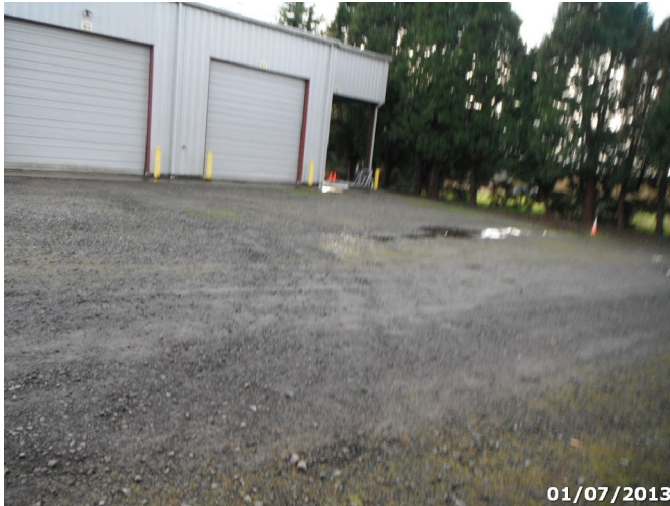
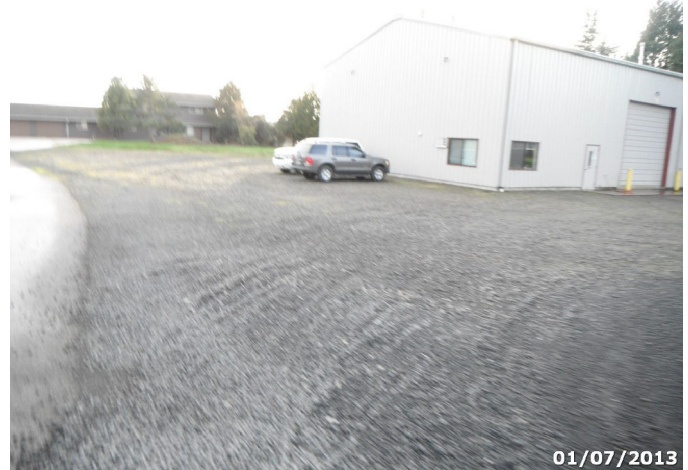
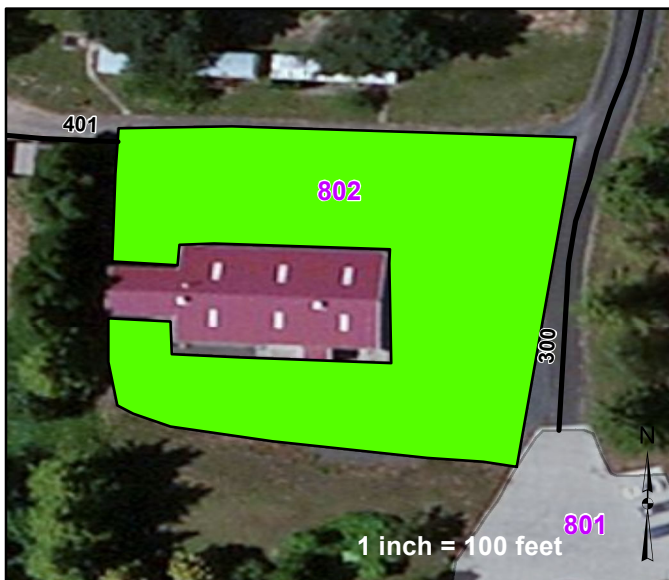
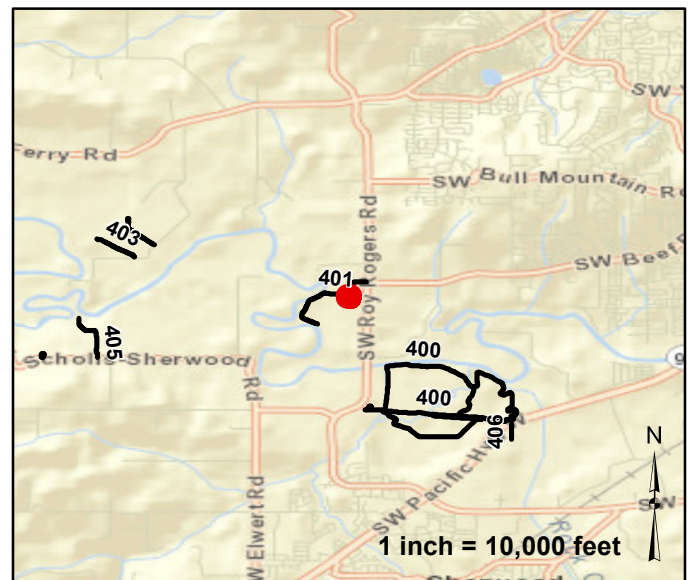
Route Number: 802

Asset Number	Area (Sq Ft)	Spaces	Condition	Surface Type	Cost to Improve	Inspection Date	Current Replacement Value
10004598	20661	50	Good	Gravel	\$3,500	01-07-2013	\$117,100

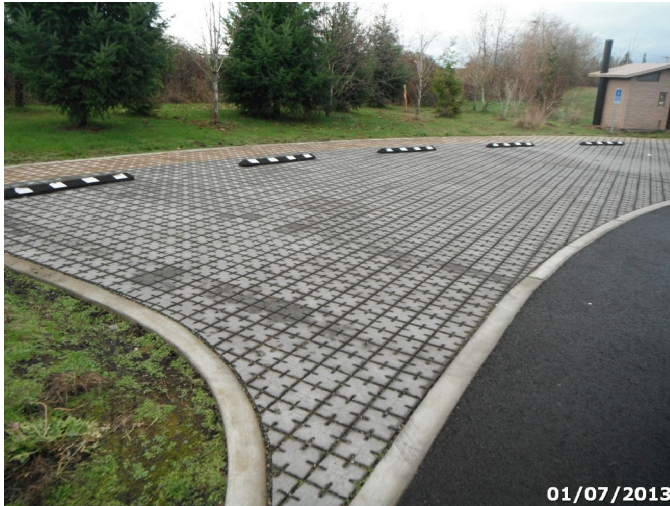
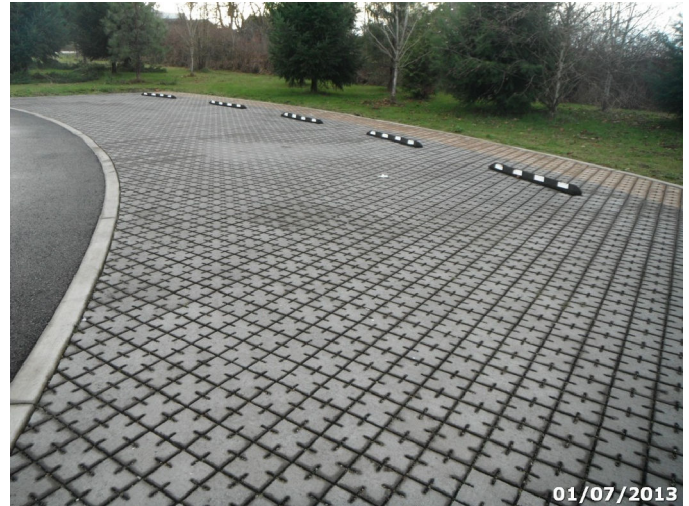
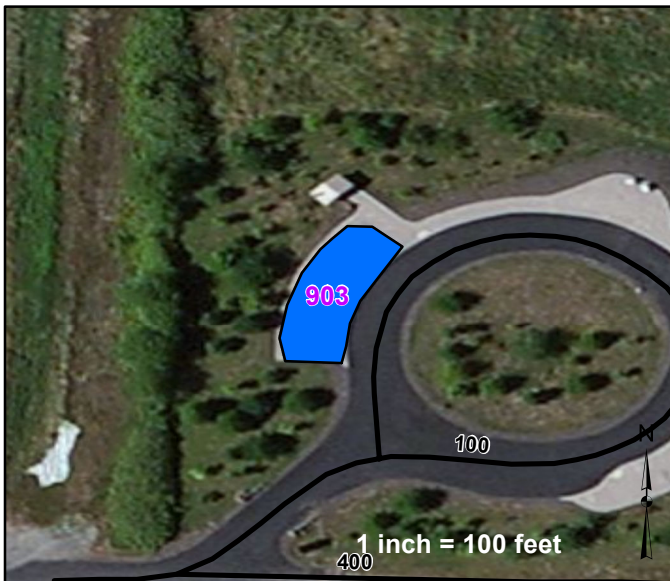
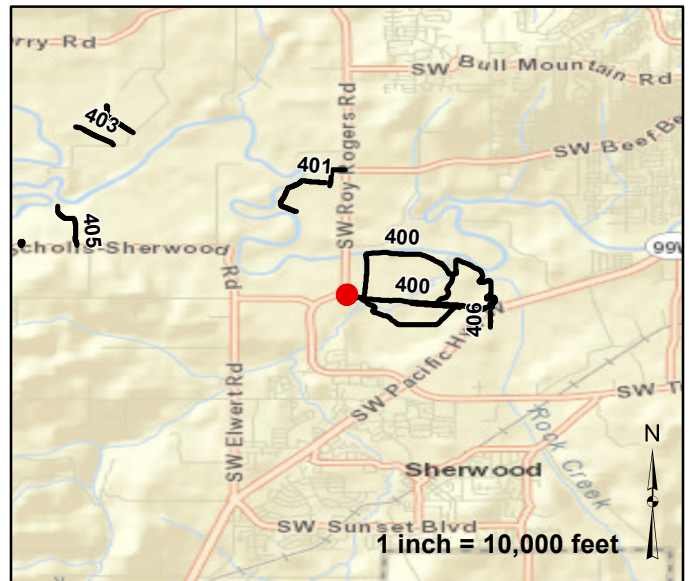
Route Number: 903 Wayside Parking Area

Asset Number	Area (Sq Ft)	Spaces	Condition	Surface Type	Cost to Improve	Inspection Date	Current Replacement Value
10054037	1776	6	Excellent	Concrete	\$0	01-07-2013	\$22,400

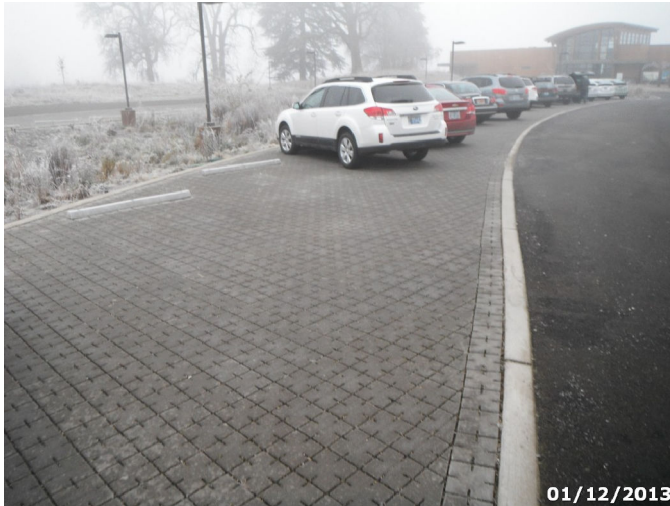
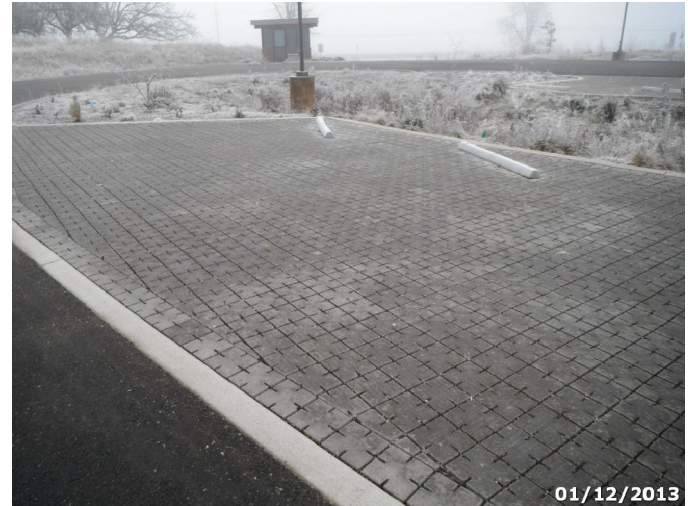
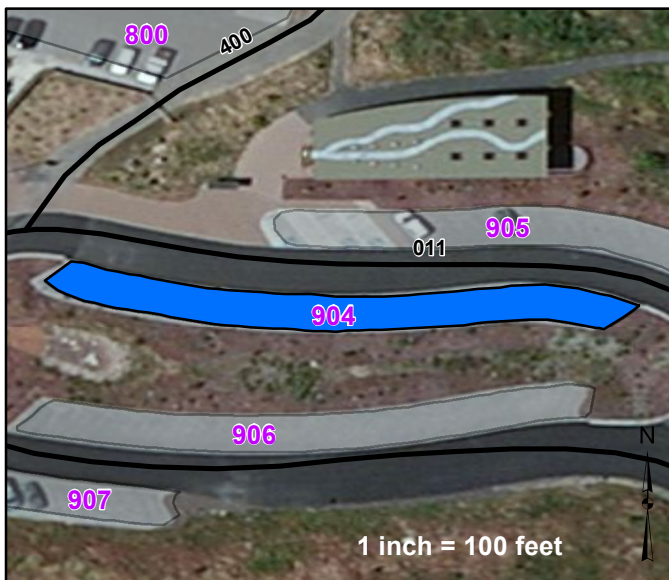
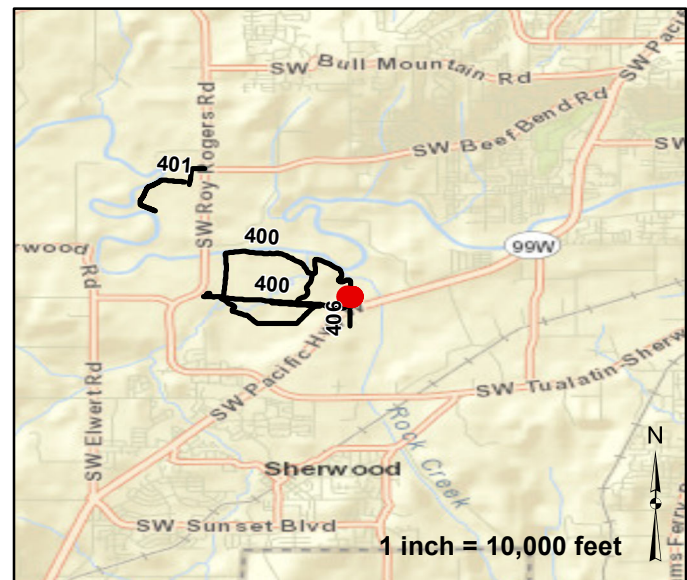
Route Number: 904
Visitor Center Parking 2
 From Visitor Center Road (Route 011)

Asset Number	Area (Sq Ft)	Spaces	Condition	Surface Type	Cost to Improve	Inspection Date	Current Replacement Value
-	3761	19	Excellent	Concrete	\$0	01-12-2013	\$47,400

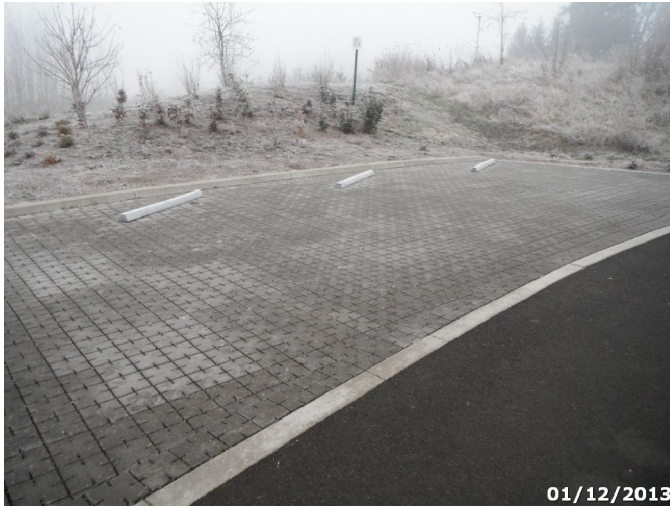
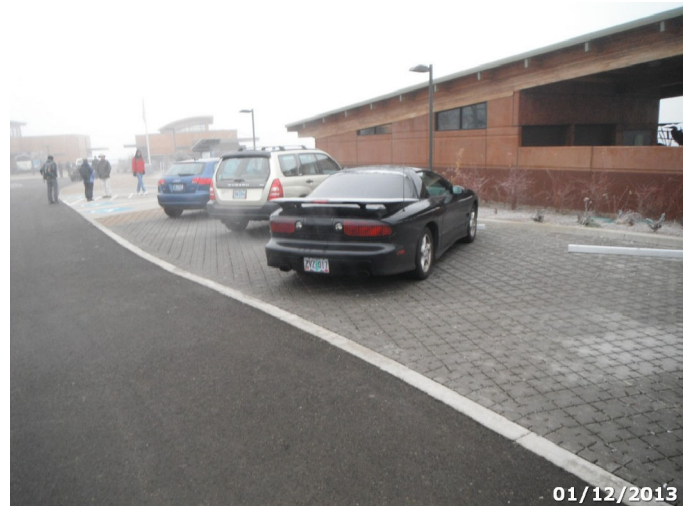
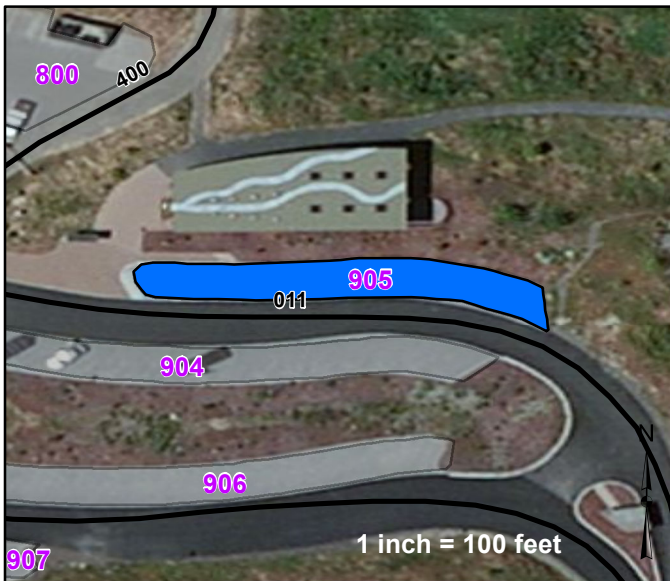
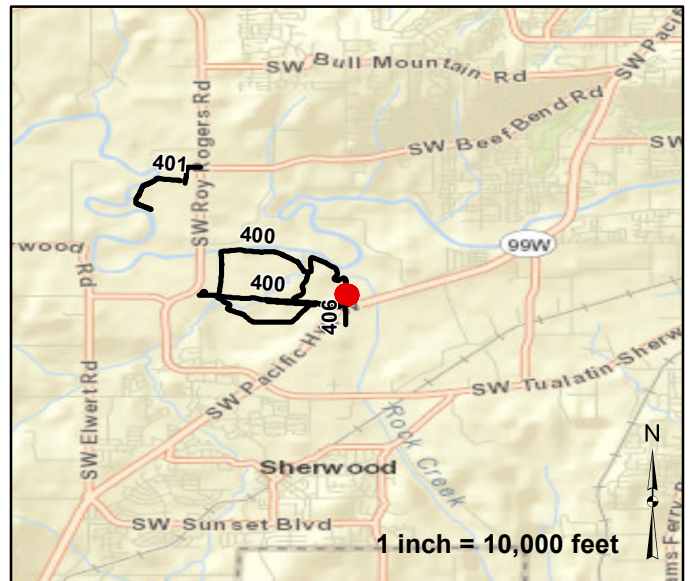
Route Number: 905
Visitor Center Parking 1
 From Visitor Center Road (Route 011)

Asset Number	Area (Sq Ft)	Spaces	Condition	Surface Type	Cost to Improve	Inspection Date	Current Replacement Value
-	2909	12	Excellent	Concrete	\$0	01-12-2013	\$36,700

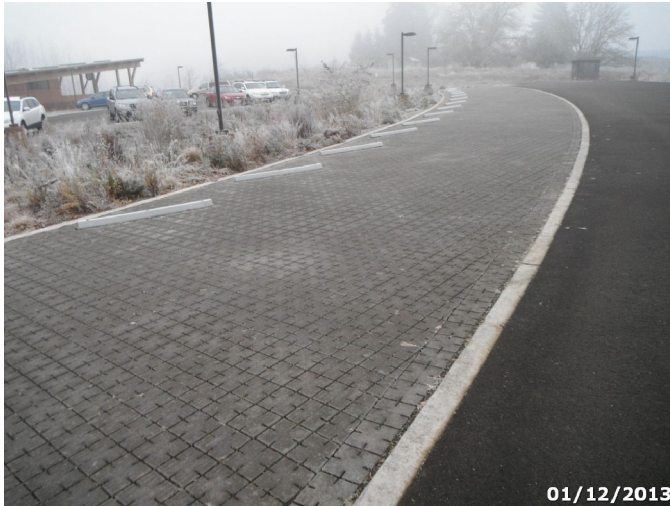
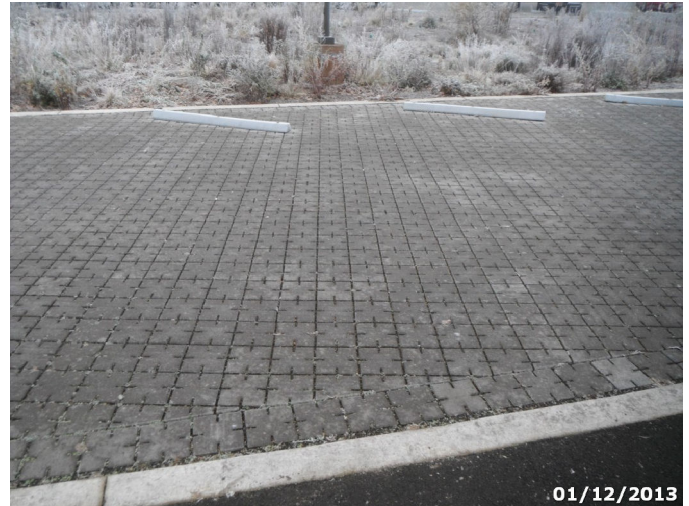
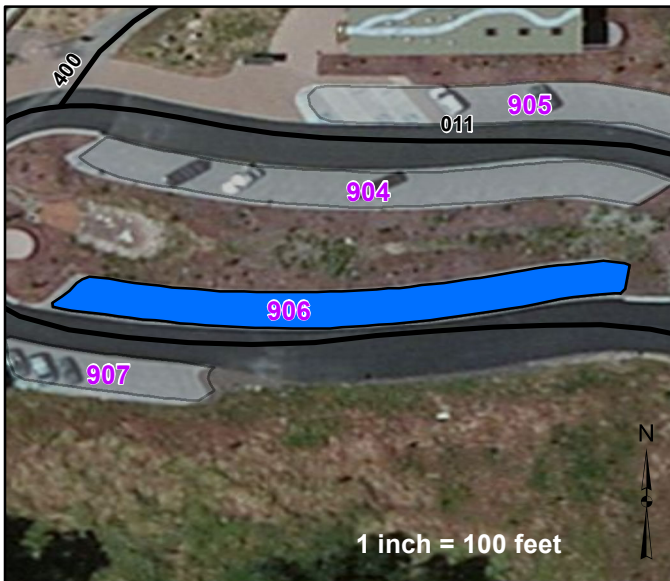
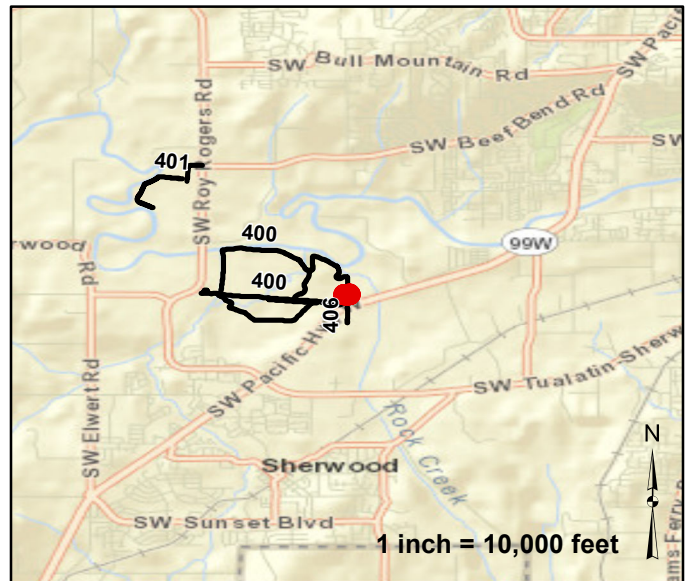
Route Number: 906
Visitor Center Parking 3
 From Visitor Center Road (Route 011)

Asset Number	Area (Sq Ft)	Spaces	Condition	Surface Type	Cost to Improve	Inspection Date	Current Replacement Value
-	3765	19	Excellent	Concrete	\$0	01-12-2013	\$47,500

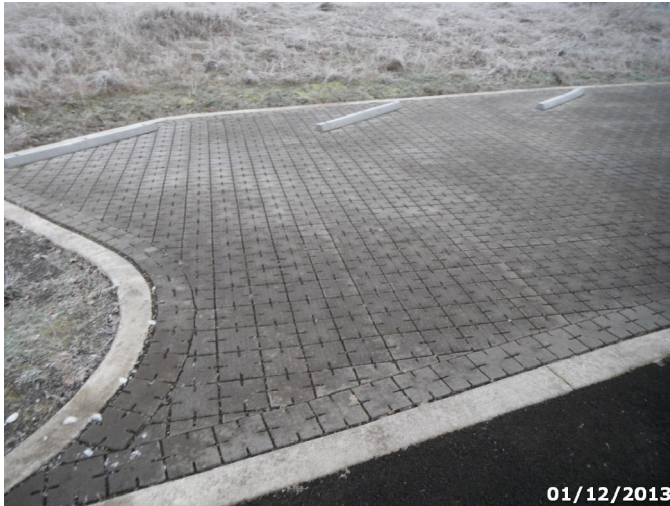
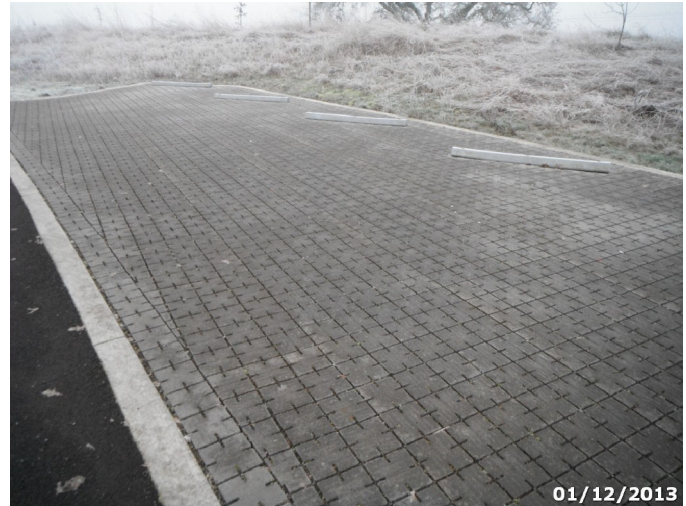
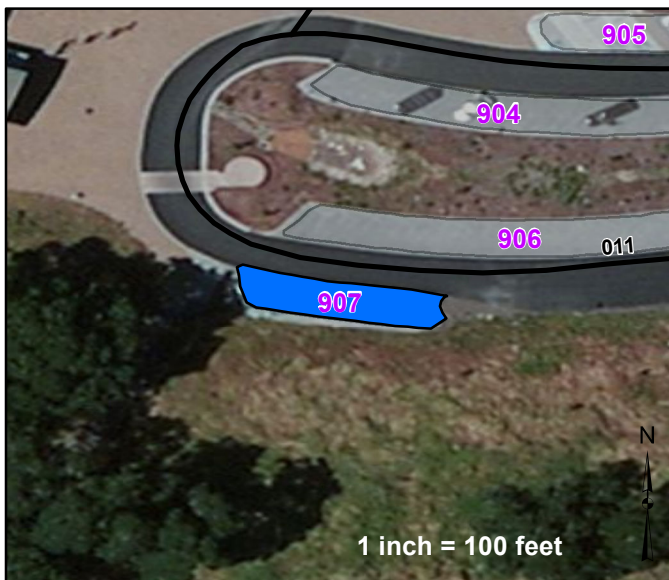
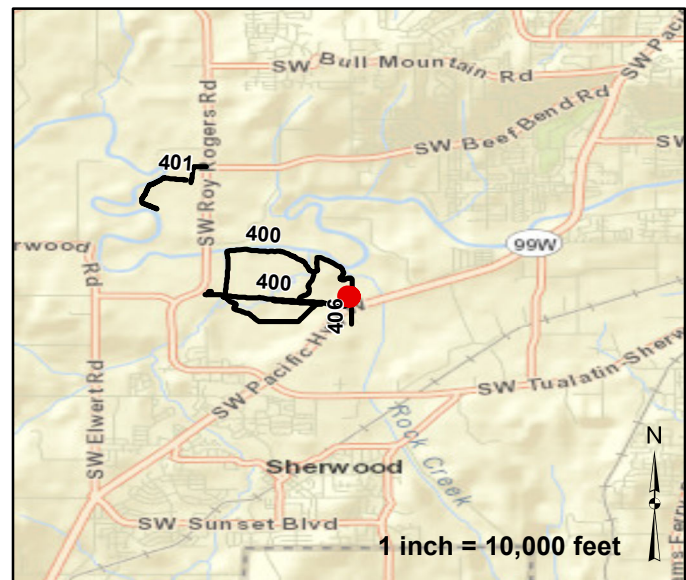
Route Number: 907
Visitor Center Parking 4
 From Visitor Center Road (Route 011)

Asset Number	Area (Sq Ft)	Spaces	Condition	Surface Type	Cost to Improve	Inspection Date	Current Replacement Value
-	1430	7	Excellent	Concrete	\$0	01-12-2013	\$18,000

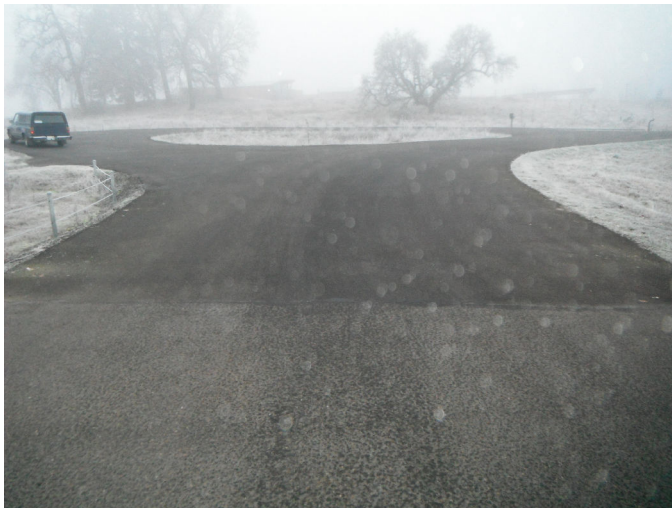
Photo: TUAL_C4_0515 Route: 011-001-0.0
Begin Section

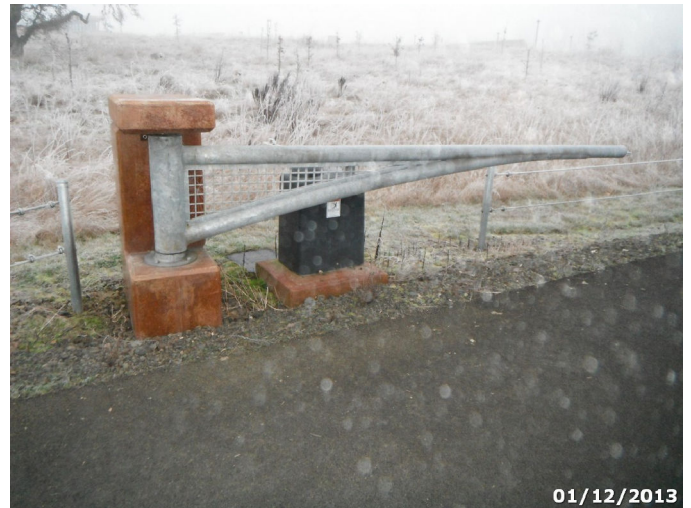
Photo: TUAL_C4_0520 Route: 011-001-0.04
Metal Open Rail Gate Electric

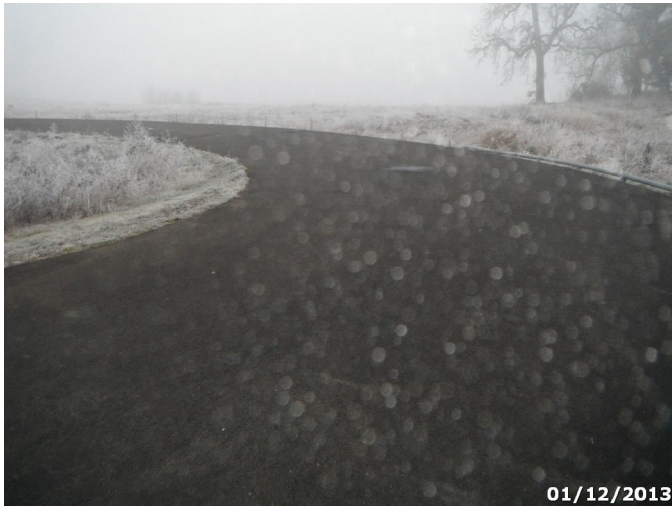
Photo: TUAL_C4_0521 Route: 011-002-0.03
Begin Section

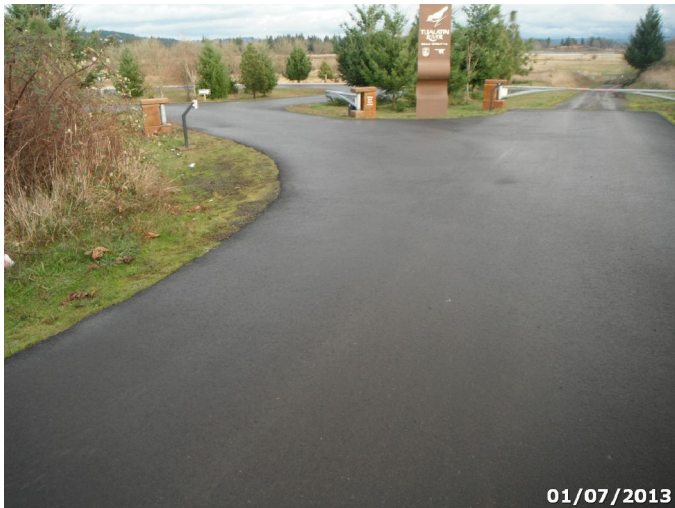
Photo: TUAL_C4_0049 Route: 100-001-0.0
Begin Section

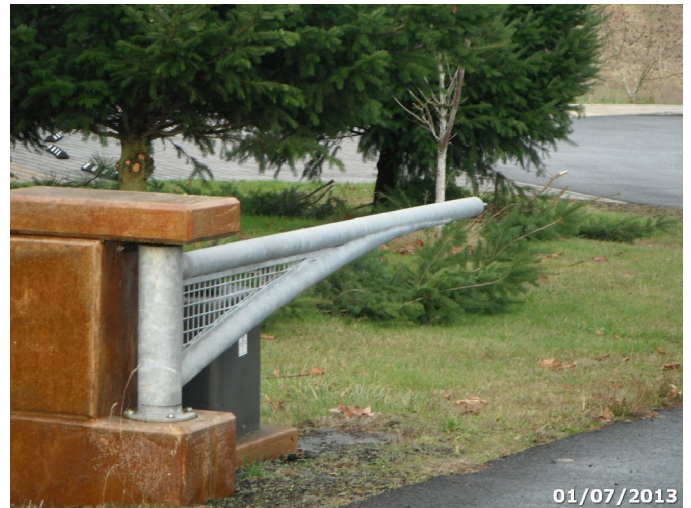
Photo: TUAL_C4_0051 Route: 100-001-0.02
Metal Open Rail Gate Electric

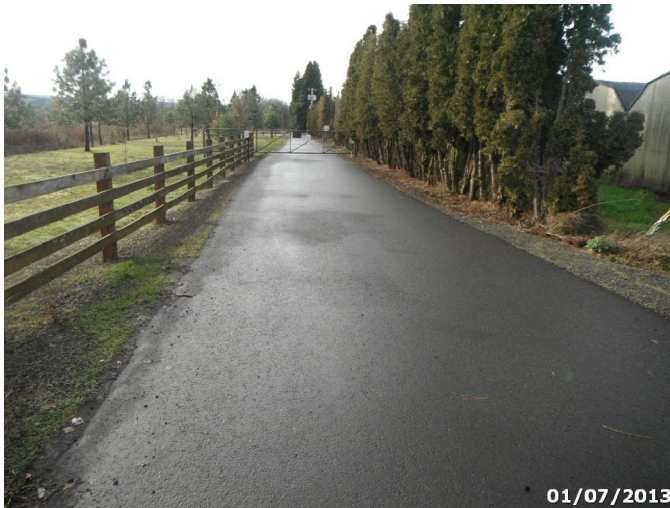
Photo: TUAL_C4_0054 Route: 300-001-0.0
Begin Section

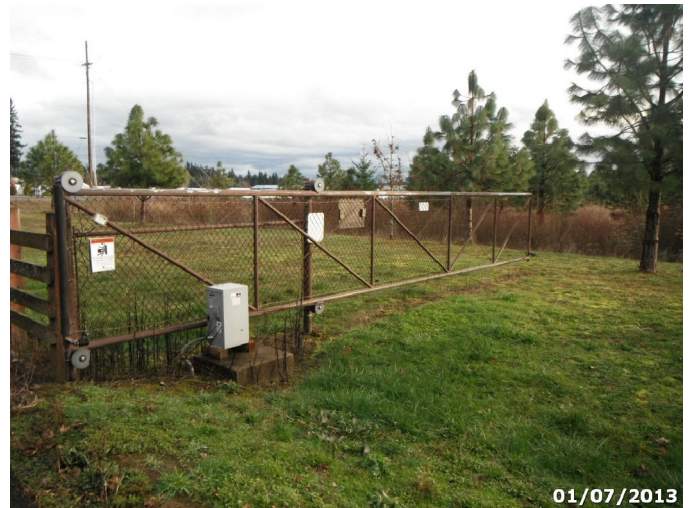
Photo: TUAL_C4_0055 Route: 300-001-0.03
Metal Chain Link Gate Electric

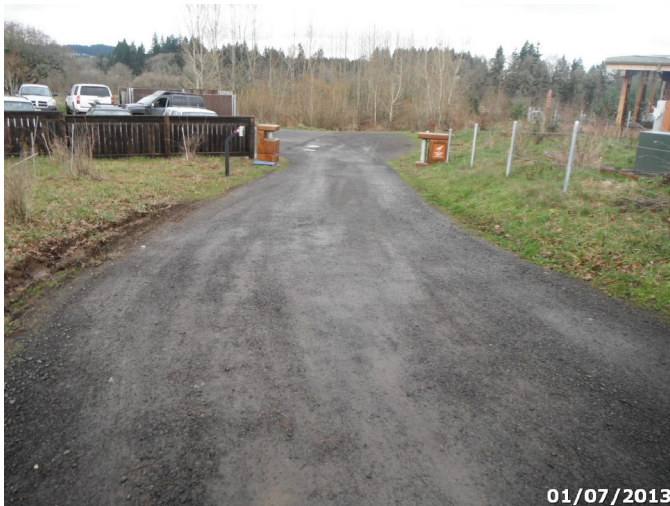
Photo: TUAL_C4_0003 Route: 400-001-0.0
Begin Section

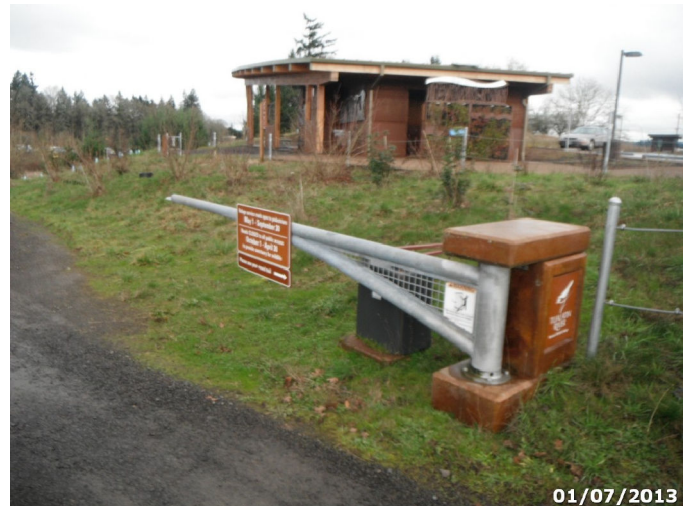
Photo: TUAL_C4_0004 Route: 400-001-0.02
Metal Open Rail Gate Electric

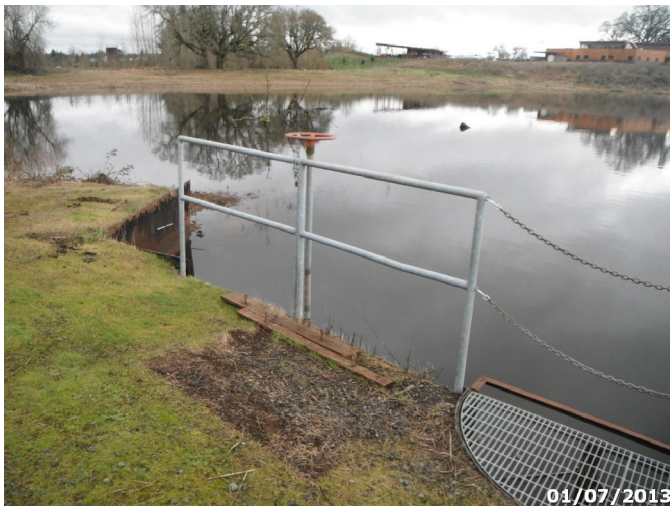
Photo: TUAL_C4_0005 Route: 400-001-0.21
Metal WCS Screw Gate 50ft long 24in dia. 3ft deep

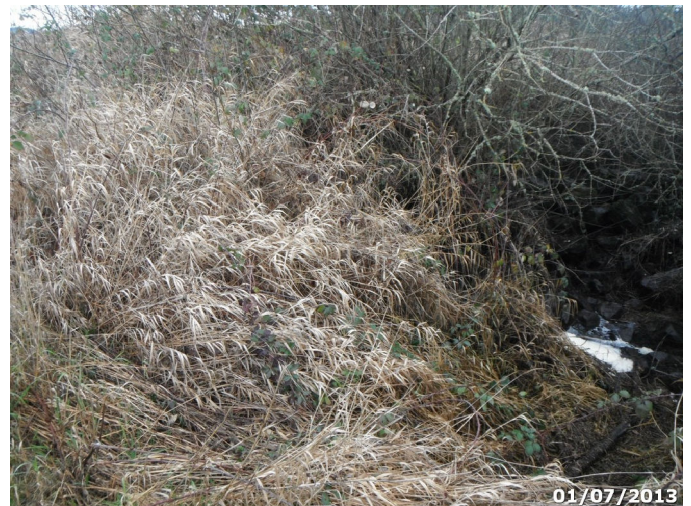
Photo: TUAL_C4_0006 Route: 400-001-0.21
Metal WCS Screw Gate 50ft long 24in dia. 3ft deep

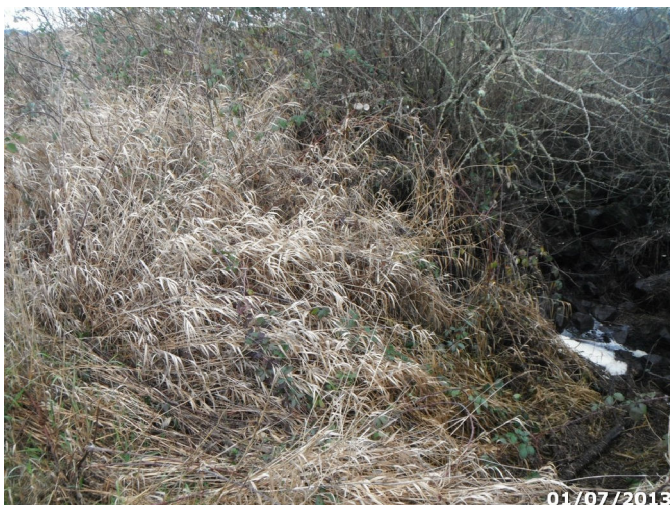
Photo: TUAL_C4_0006 Route: 400-001-0.21
Metal WCS Flashboard Riser 50ft long 36in dia. 6ft deep

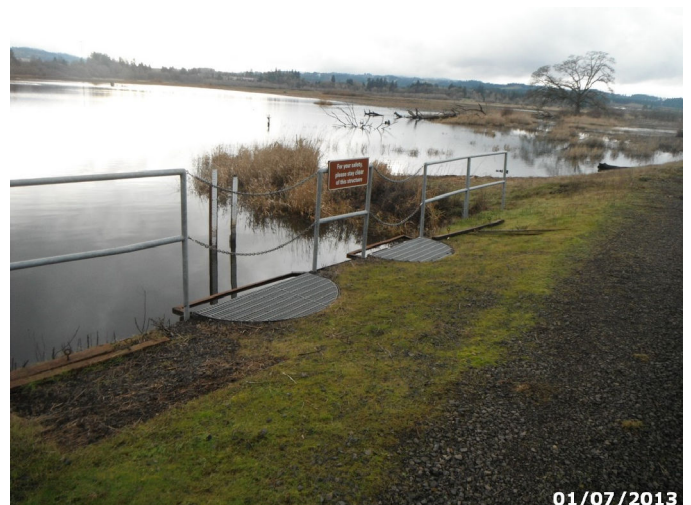
Photo: TUAL_C4_0007 Route: 400-001-0.21
Metal WCS Flashboard Riser
50ft long 36in dia. 6ft deep

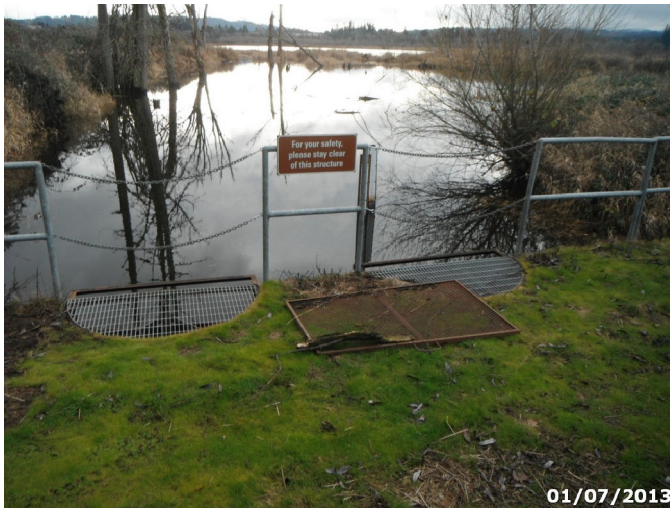
Photo: TUAL_C4_0008 Route: 400-001-0.74
Metal WCS Flashboard Riser 50ft long 36in dia. 6ft deep

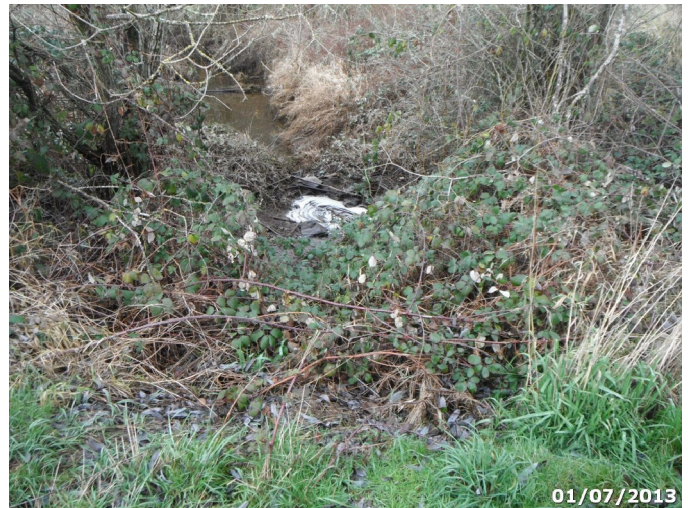
Photo: TUAL_C4_0010 Route: 400-001-0.74
Metal WCS Flashboard Riser 50ft long 36in dia. 6ft deep

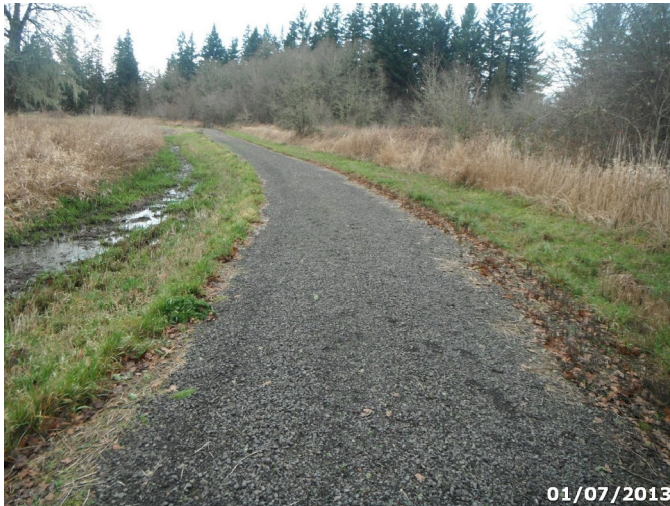
Photo: TUAL_C4_0011 Route: 400-002-0.97
Begin Section

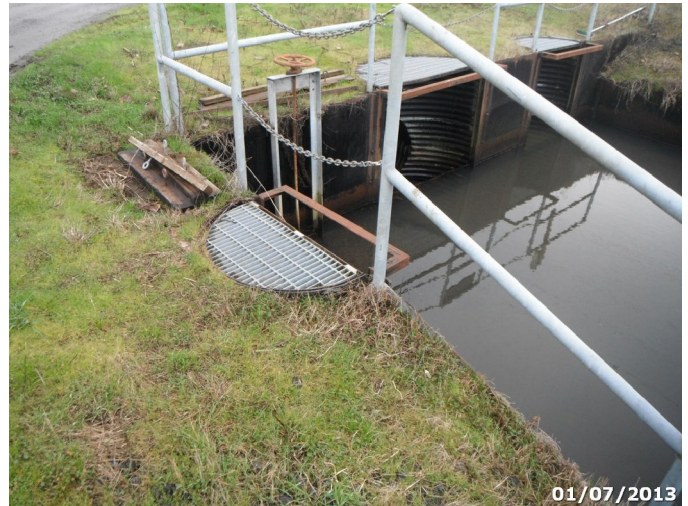
Photo: TUAL_C4_0012 Route: 400-002-1.86
Metal WCS Flashboard Riser 50ft long 24in dia. 3ft deep

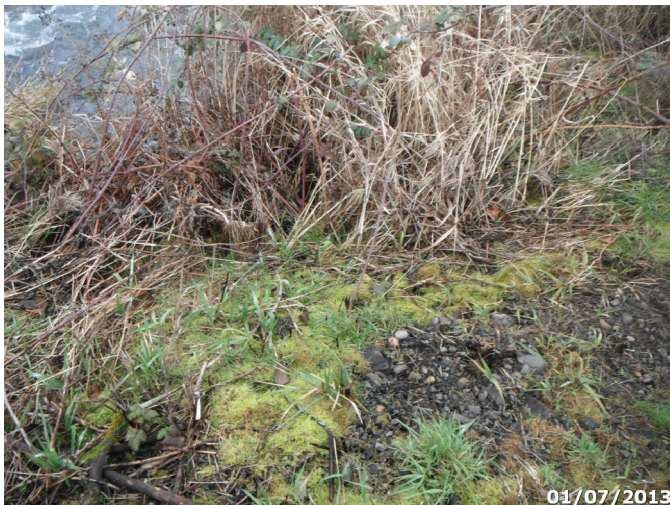
Photo: TUAL_C4_0013 Route: 400-002-1.86
Metal WCS Flashboard Riser 50ft long 24in dia. 3ft deep

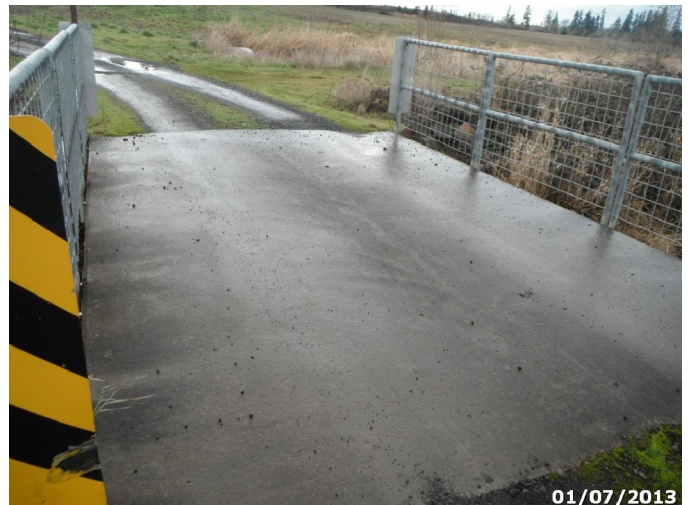
Photo: TUAL_C4_0016 Route: 400-002-1.87
Concrete Bridge NBIS:13600-00041
Chicken Creek Bridge Asset# 10004624

Tualatin - 13600 Bridge Inventory					
Rte #	Milepost	NBIS #	Sufficiency Rating	Functionally Obsolete	Structurally Deficient
400	1.87	13600-00041	NA	NA	NA

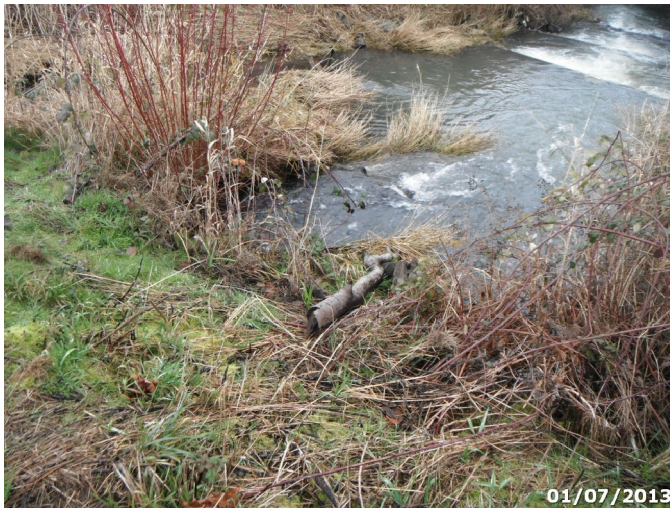
Photo: TUAL_C4_0014 Route: 400-002-1.87
Metal WCS Flashboard Riser 40ft long 48in dia. 2ft deep

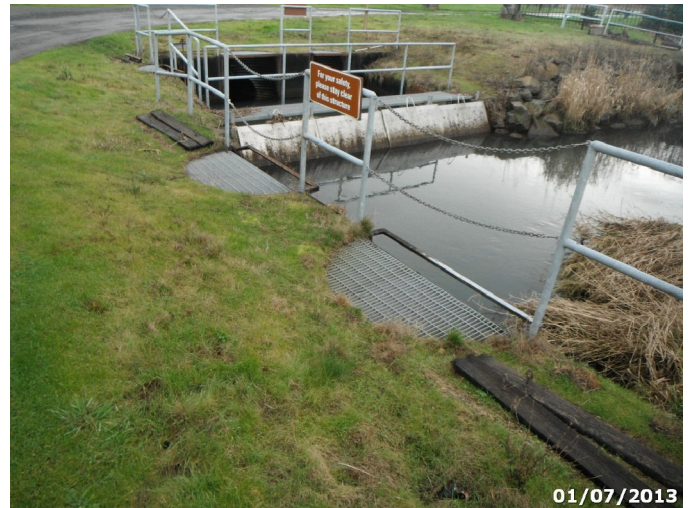
Photo: TUAL_C4_0015 Route: 400-002-1.87
Metal WCS Flashboard Riser 40ft long 48in dia. 2ft deep

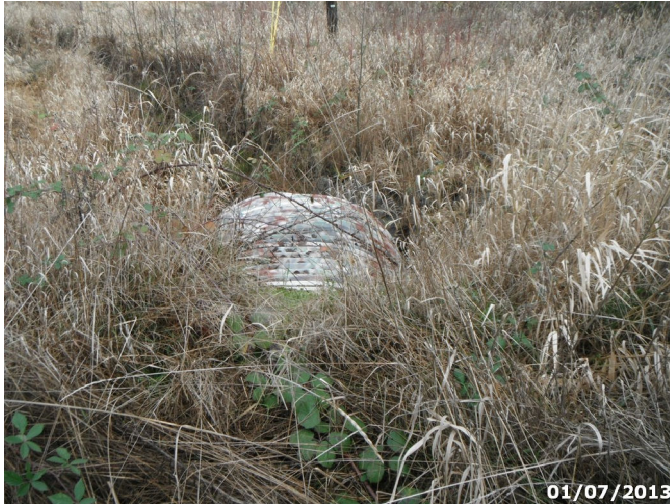
Photo: TUAL_C4_0017 Route: 400-002-1.89
Metal Culvert 50ft long 72in dia. 2ft deep

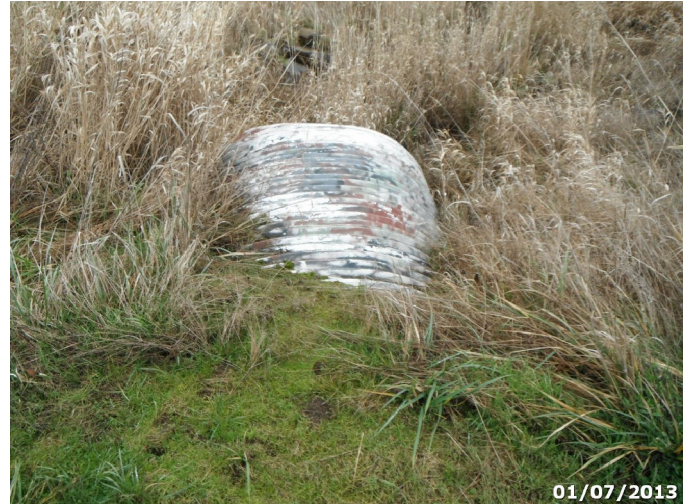
Photo: TUAL_C4_0018 Route: 400-002-1.89
Metal Culvert 50ft long 72in dia. 2ft deep

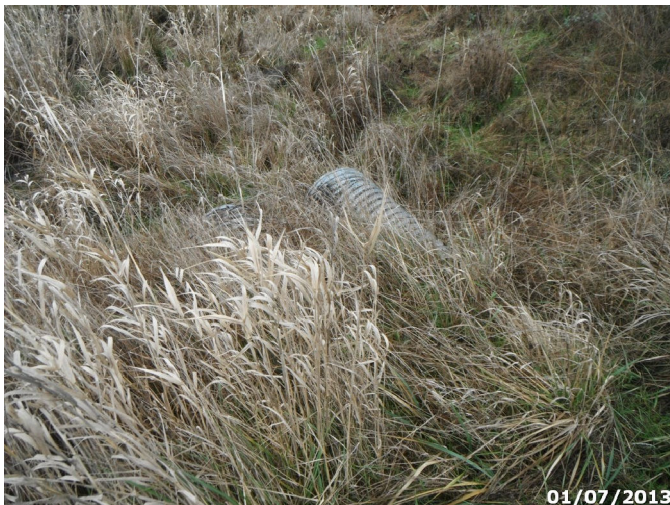
Photo: TUAL_C4_0019 Route: 400-002-1.89
Metal Culvert 50ft long 24in dia. 2ft deep

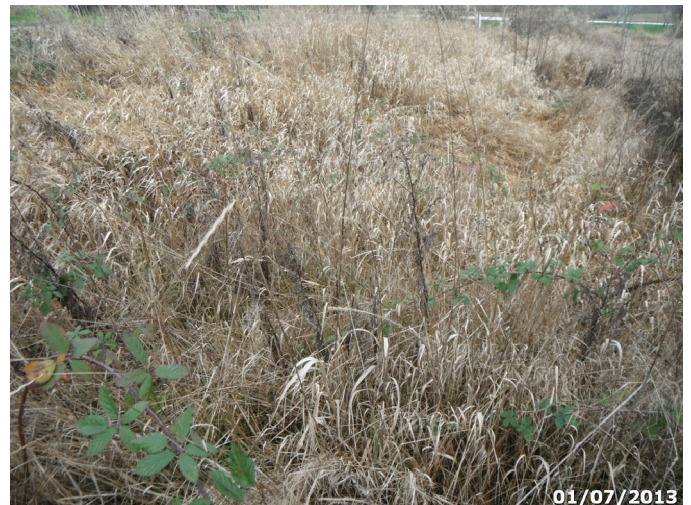
Photo: TUAL_C4_0020 Route: 400-002-1.89
Metal Culvert 50ft long 24in dia. 2ft deep

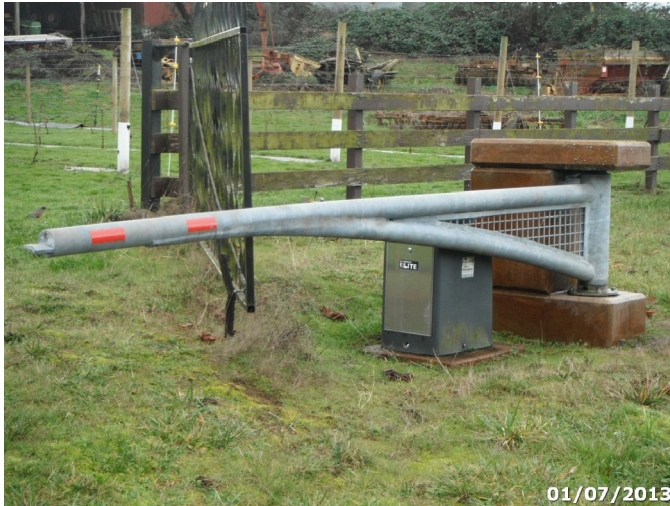
Photo: TUAL_C4_0021 Route: 400-002-1.98
Metal Open Rail Gate Electric

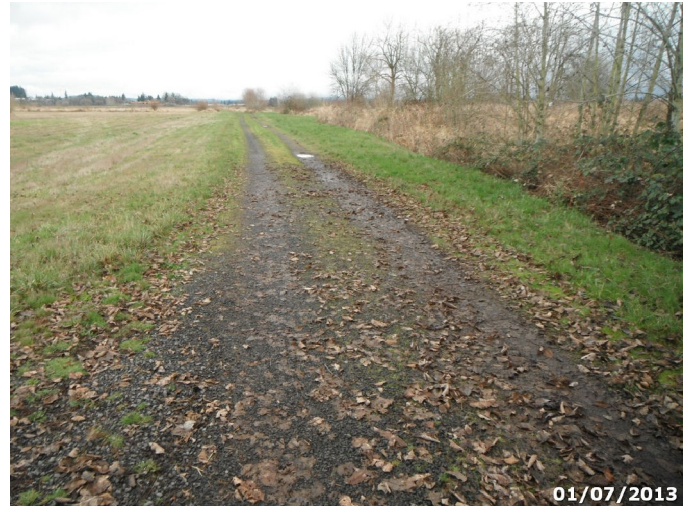
Photo: TUAL_C4_0022 Route: 400-003-1.84
Begin Section

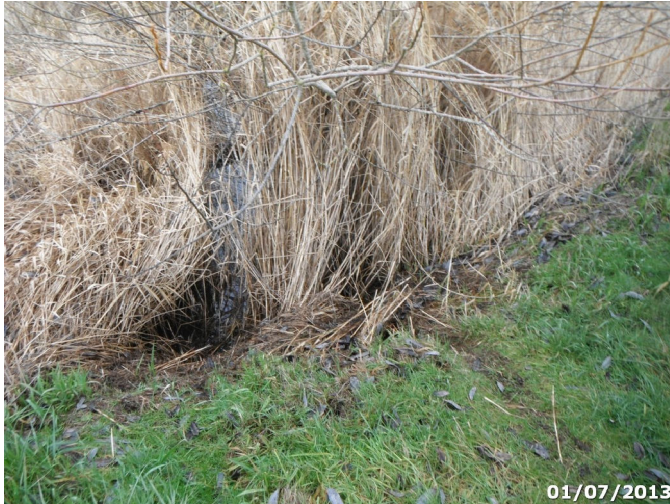
Photo: TUAL_C4_0023 Route: 400-003-2.02
Metal WCS Flashboard Riser 40ft long 24in dia. 1ft deep

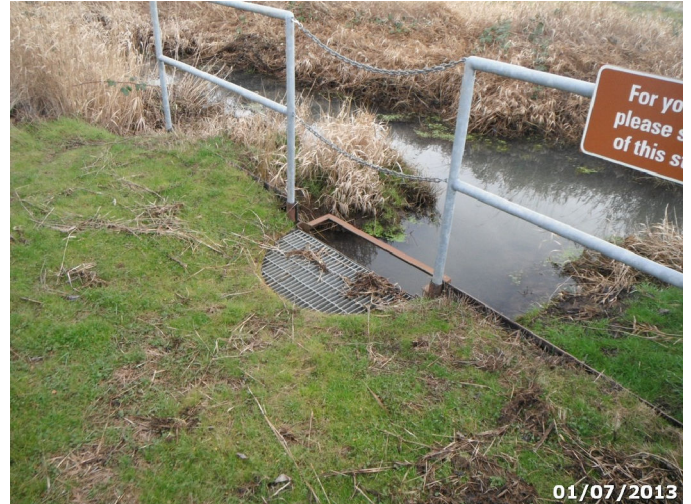
Photo: TUAL_C4_0024 Route: 400-003-2.02
Metal WCS Flashboard Riser 40ft long 24in dia. 1ft deep
